# Infrared Thermography: A Tool for Defect Identification

Akash Padole<sup>1</sup>, Dr. Sumedh Mhaske<sup>2</sup>

**Abstract:** *In this work, the potential of infrared thermography (IRT) to assess moisture related phenomenon was tested. Infrared thermography, due to its non-contact character that allows for quick surface mapping, represents a powerful tool for non-destructive testing (NDT) of materials and structures. As Infrared thermography is still not completely exploited and traditional methods are still employed. Due to the ambiguity in the analysis by using traditional methods of non-destructive testing this method emerges as an easy and quick method. So, in this paper, different areas were taken for inspection on the college campus and at the same location traditional method of NDT were also performed and the results are compared. The same has also been performed by casting the concrete cube having porous pipes inserted into a cube and the source of leakages was detected. At last the cost required by the conventional method and IRT was compared and found that the cost required by IRT was much economical than convention method Thus, anomalies were found during a short-ela

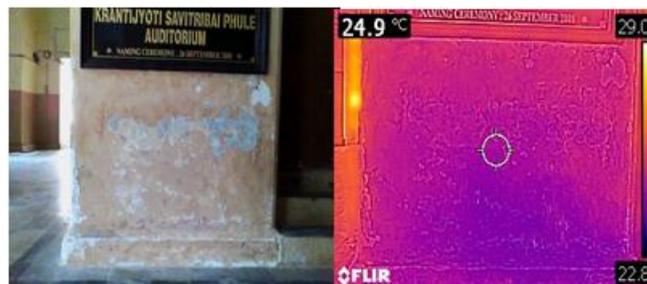
Figure 2: Auditorium Main Door

In Figure 2 the moisture gets accumulated due to the ground water source and creates the dampness on the wall.

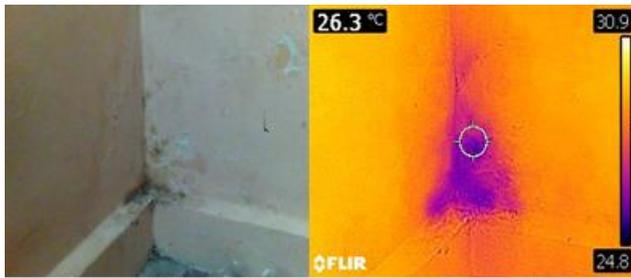
Figure 3: Computer Department Class room

In Figure 3 the accumulation of moisture at the corner of the wall and the blue portion shows the extent to which the moisture has spread on the wall.

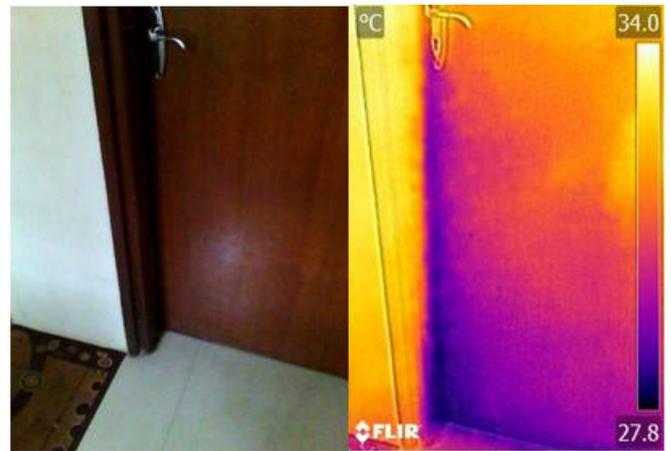
Figure 8: Air leakage through Meeting room

In Figure 8 the air leakage of the door has shown even though the door is closed the cold air is leaking between the door and the casing.

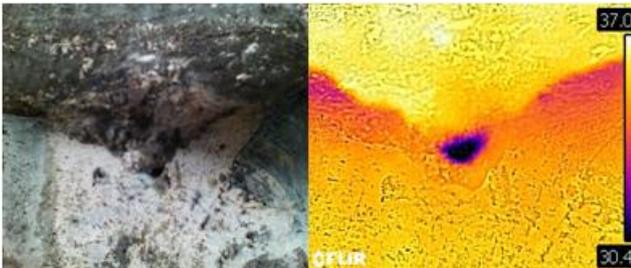
Figure 4: Water Tank no. 24 at terrace

Figure 4 is the thermogram of the water tank at the terrace of the building showing the leakage at the bottom in the dark violet color which has not seen in naked eyes.

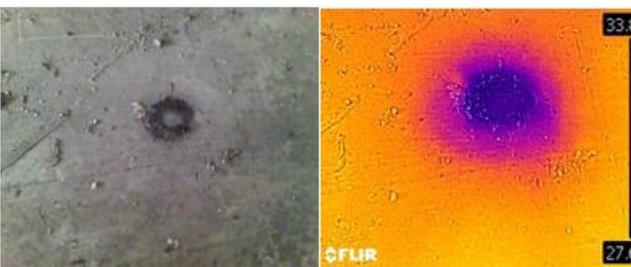
Figure 5: Spread of water on terrace

In Figure 5 the spread of water cannot be seen clearly with naked eyes but in thermogram, the spread of water can be seen clearly in pink color.

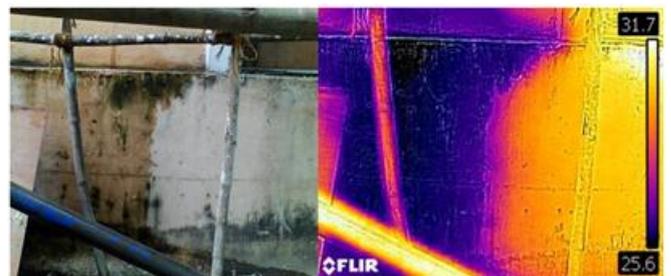
Figure 9: Outside the Mechanical Workshop

In Figure 9 the water is continuously falling on the wall which ultimately reduces the strength and the appearance of the wall, so the extent of which the wall gets deteriorate can be seen in the thermogram.

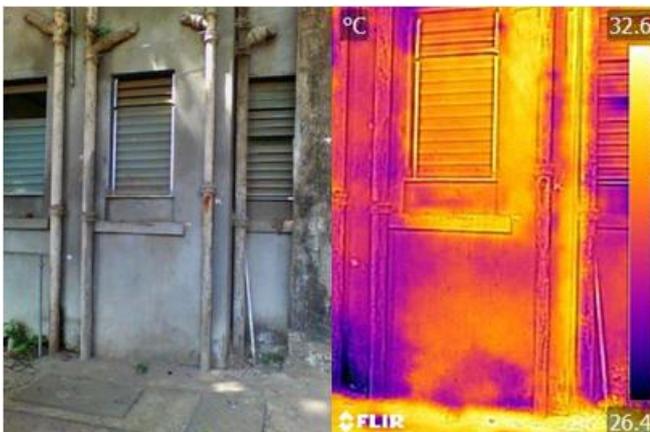
Figure 6: Behind Computer Department Toilet

Figure 6 is the newly constructed lavatory in the department. In this, the portion in the pink shows some of the leakages of which mostly accumulated near the pipelines.

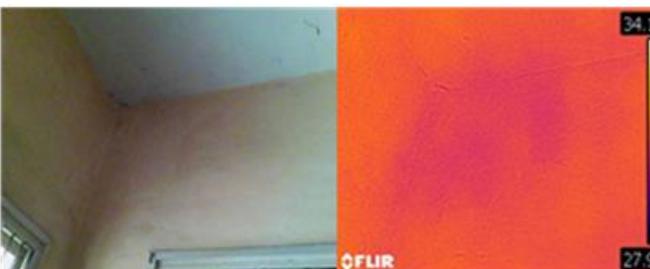
Figure 7: Electrical Department at Second floor

Figure 7 shows the improper insulation at the top corner of the building which can be seen with the pink color in the vertical pattern.

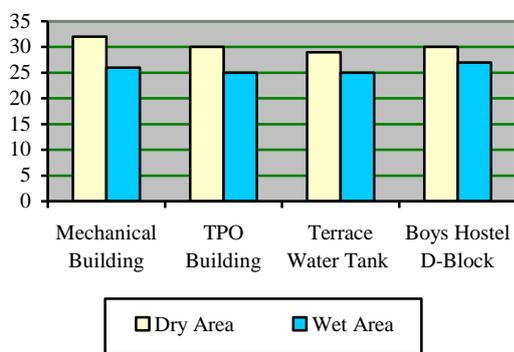
Figure 11: Result of Rebound Hammer Test

The last step is to cross check with the rebound hammer. The following bar chart shows the reading collected on site testing using rebound hammer testing. Y-axis shows the Rebound Hammer Number. The strength of concrete on dry area is 32 N/mm<sup>2</sup> while on wet area, its strength comes to 26 N/mm<sup>2</sup> in case of Mechanical Building, which shows that the strength comes more on dry area rather than wet area. So, in thermogram on yellow shows the dry portion while violet shows the wet one. The rebound value was come to be lesser when the test performed on the wet area because the strength gets considerably reduces when the wall become wet. On several other areas, the test was conducted to make sure that the result obtained from the thermal camera was absolute.

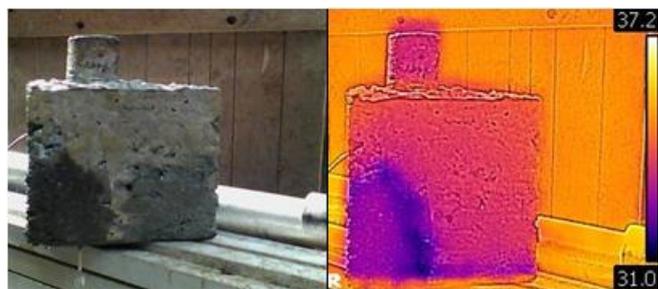
Figure 13: After pouring water

As seen from the Figure 13. The source of leakage can be easily detected. The dark blue portion shows the accumulation of water in the concrete block. For experiment purpose, the water was poured in the pipe which is in the concrete block and kept for some time.

Figure 12 is the thermogram prior to pouring the water. After that, the water started leaking out of the concrete block. In Figure 13 as we can see in the normal photo it was hard to predict the exact location of leakage but in thermogram, the dark violet shows the most accumulation of water which is ultimately the source of leakage.
