# Infrared Thermography: A Tool for Defect Identification

**Abstract:** *In this work, the potential of infrared thermography (IRT) to assess moisture related phenomenon was tested. Infrared thermography, due to its non-contact character that allows for quick surface mapping, represents a powerful tool for non-destructive testing (NDT) of materials and structures. As Infrared thermography is still not completely exploited and traditional methods are still employed. Due to the ambiguity in the analysis by using traditional methods of non-destructive testing this method emerges as an easy and quick method. So, in this paper, different areas were taken for inspection on the college campus and at the same location traditional method of NDT were also performed and the results are compared. The same has also been performed by casting the concrete cube having porous pipes inserted into a cube and the source of leakages was detected. At last the cost required by the conventional method and IRT was compared and found that the cost required by IRT was much economical than convention method Thus, anomalies were found during a short-elapsd time. The infrared thermography is useful in detectin

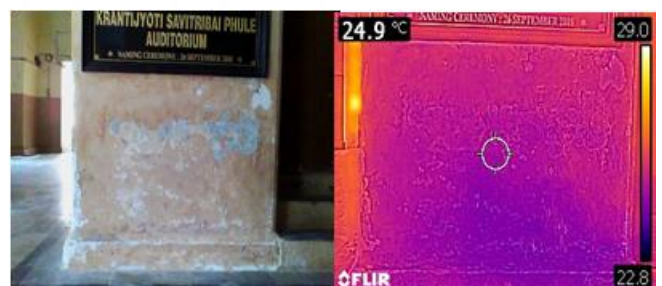
Figure 2: Auditorium Main Door

In Figure 2 the moisture gets accumulated due to the ground water source and creates the dampness on the wall.

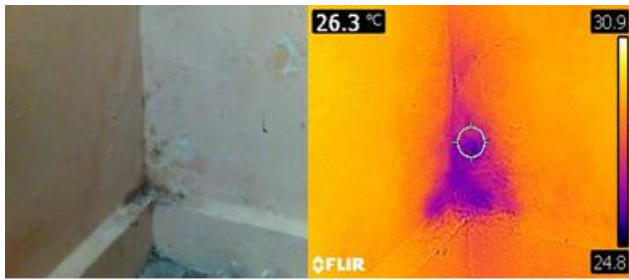
Figure 3: Computer Department Class room

In Figure 3 the accumulation of moisture at the corner of the wall and the blue portion shows the extent to which the moisture has spread on the wall.

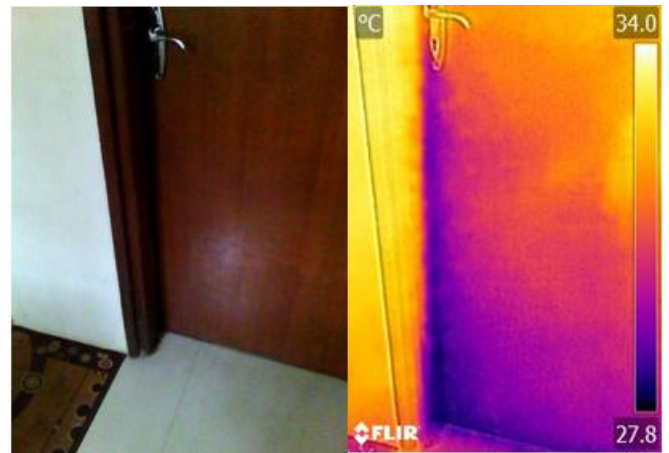
Figure 8: Air leakage through Meeting room

In Figure 8 the air leakage of the door has shown even though the door is closed the cold air is leaking between the door and the casing.

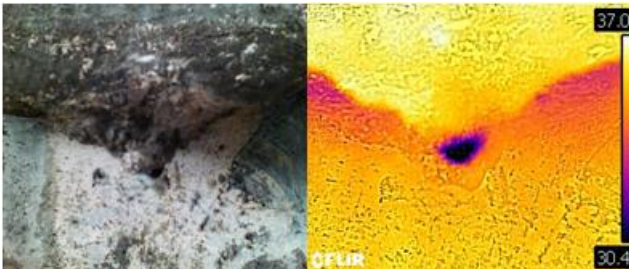
Figure 4: Water Tank no. 24 at terrace

Figure 4 is the thermogram of the water tank at the terrace of the building showing the leakage at the bottom in the dark violet color which has not seen in naked eyes.

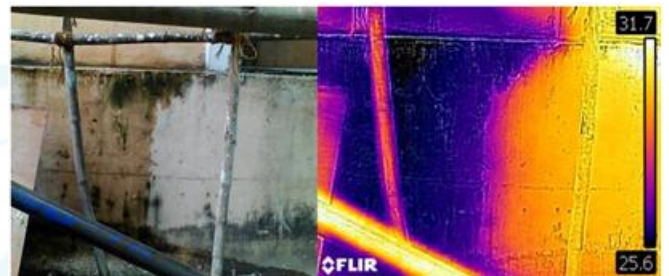
Figure 9: Outside the Mechanical Workshop

In Figure 9 the water is continuously falling on the wall which ultimately reduces the strength and the appearance of the wall, so the extent of which the wall gets deteriorate can be seen in the thermogram.

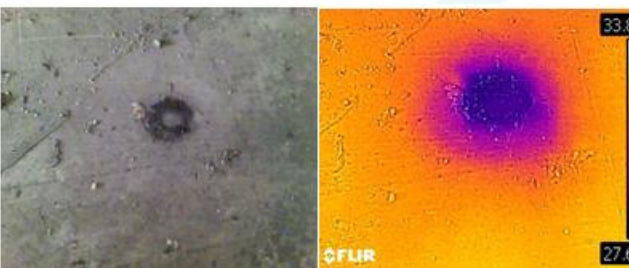
Figure 5: Spread of water on terrace

In Figure 5 the spread of water cannot be seen clearly with naked eyes but in thermogram, the spread of water can be seen clearly in pink color.

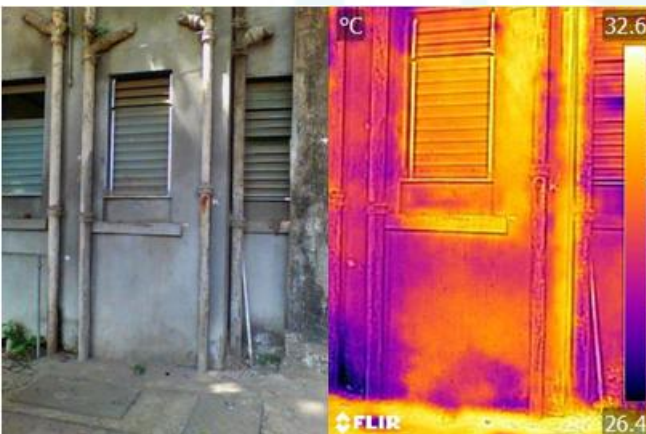
Figure 6: Behind Computer Department Toilet

Figure 6 is the newly constructed lavatory in the department. In this, the portion in the pink shows some of the leakages of which mostly accumulated near the pipelines.

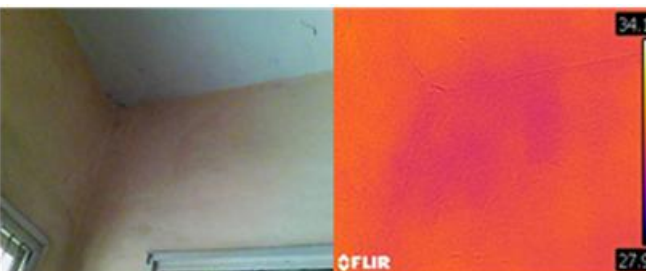
Figure 7: Electrical Department at Second floor

Figure 7 shows the improper insulation at the top corner of the building which can be seen with the pink color in the vertical pattern.

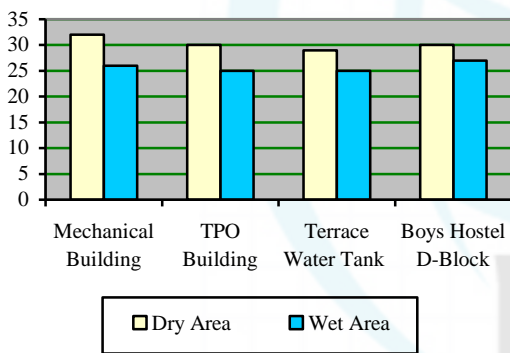
Figure 11: Result of Rebound Hammer Test

The last step is to cross check with the rebound hammer. The following bar chart shows the reading collected on site testing using rebound hammer testing. Y-axis shows the Rebound Hammer Number. The strength of concrete on dry area is 32 N/mm<sup>2</sup> while on wet area, its strength comes to 26 N/mm<sup>2</sup> in case of Mechanical Building, which shows that the strength comes more on dry area rather than wet area. So, in thermogram on yellow shows the dry portion while violet shows the wet one. The rebound value was come to be lesser when the test performed on the wet area because the strength gets considerably reduces when the wall become wet. On several other areas, the test was conducted to make sure that the result obtained from the thermal camera was absolute.

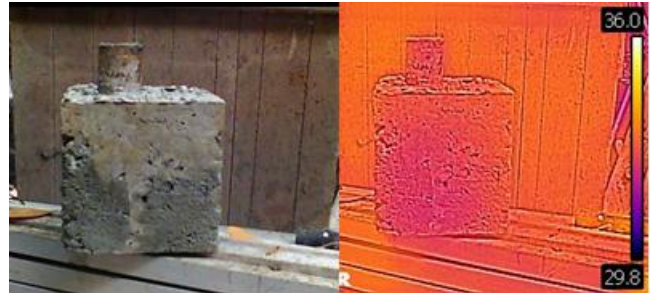
Figure 12: Before pouring water

Figure 12 is the thermogram prior to pouring the water. After that, the water started leaking out of the concrete block. In Figure 13 as we can see in the normal photo it was hard to predict the exact location of leakage but in thermogram, the dark violet shows the most accumulation of water which is ultimately the source of leakage.

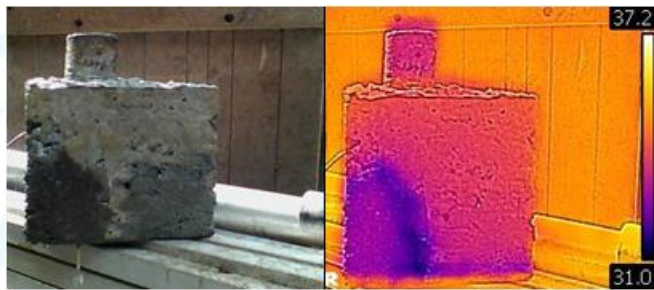
Figure 13: After pouring water

As seen from the Figure 13. The source of leakage can be easily detected. The dark blue portion shows the accumulation of water in the concrete block. For experiment purpose, the water was poured in the pipe which is in the concrete block and kept for some time.
