Assessment of Heritage Churches in Isabela, Cagayan Valley

Susan C. Vallejo

College of Engineering, Architecture & Technology, Isabela State University, Ilagan, Philippines

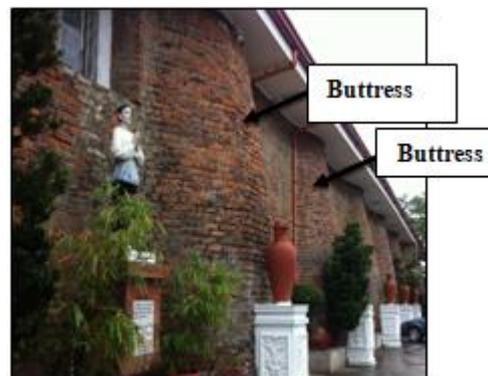
Figure 1: The presence of buttresses at our Lady of Atocha Parish Church

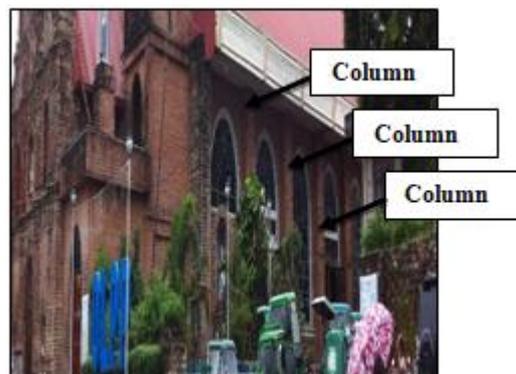
Figure 2: The presence of columns at our Lady of Pillar Parish Church

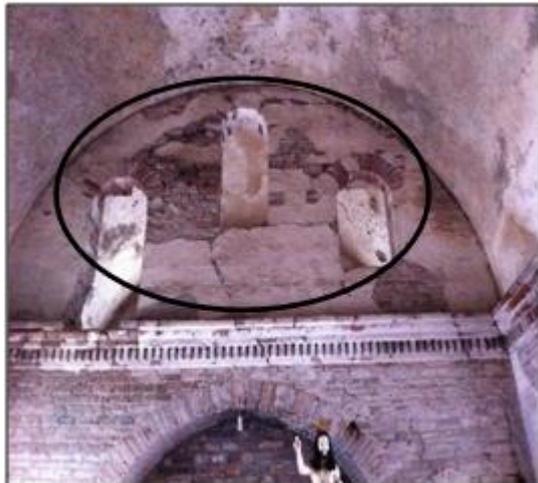
Table 3 shows the structural defects and damages of the churches. As observed, cracks were found on walls of all the five (5) churches as shown in fig. 3a and 3b below, while no cracks can be seen in floor slabs of these heritage buildings. From this result, the damaged on the walls of the churches which are caused by the presence of cracks contributes to the deterioration of the structural members of the building.

Figure 3 (a): cracks on the walls of the St. Matthias

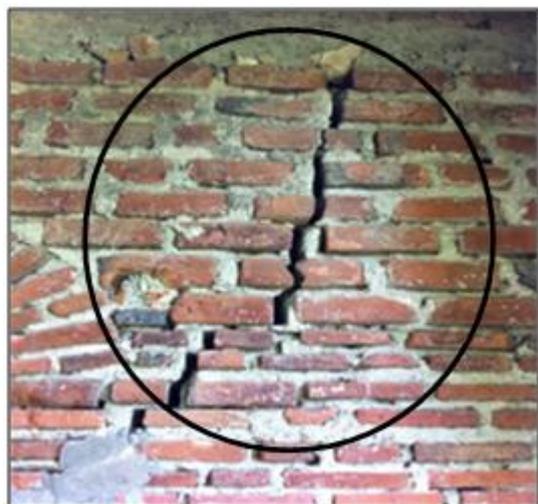
Figure 3 (b): Cracks on the walls of San Pablo de Cabigan Parish Church

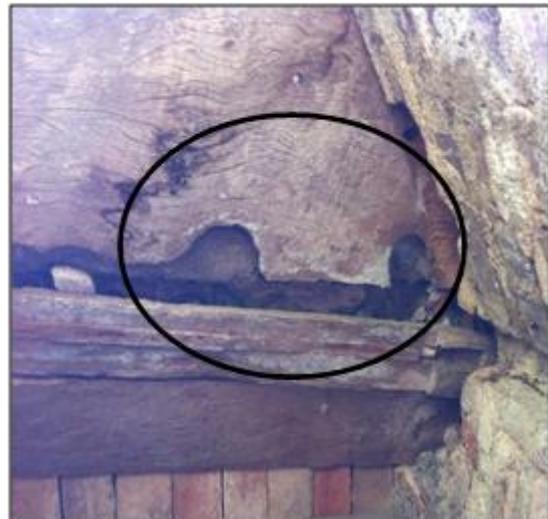
Moreover, there were human errors observed at St. Rose of Lima Parish Church, Our Lady of Atocha Parish Church and at San Pablo de Cabigan Church. An example is the improper installation of electrical wirings which was observed at St. Matthias Parish Church. However, it was observed that only at St. Rose of Lima Parish Church, where decay of timber structures was present.

Figure 4: Timber decay at Saint Rose of Lima Parish Church

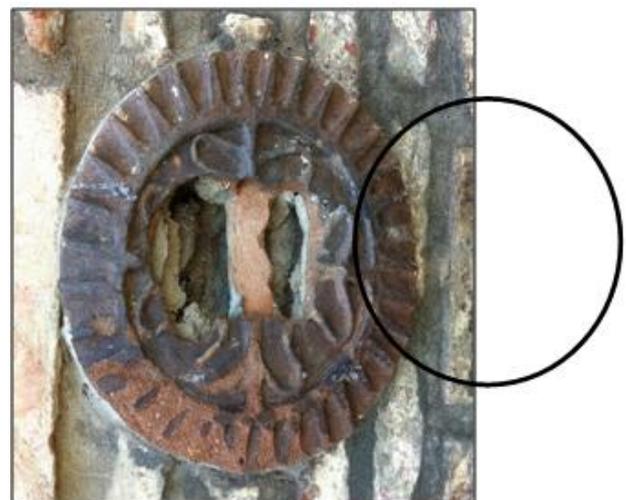
Figure 5: Damaged stoned details St. Rose of Lima Parish Church

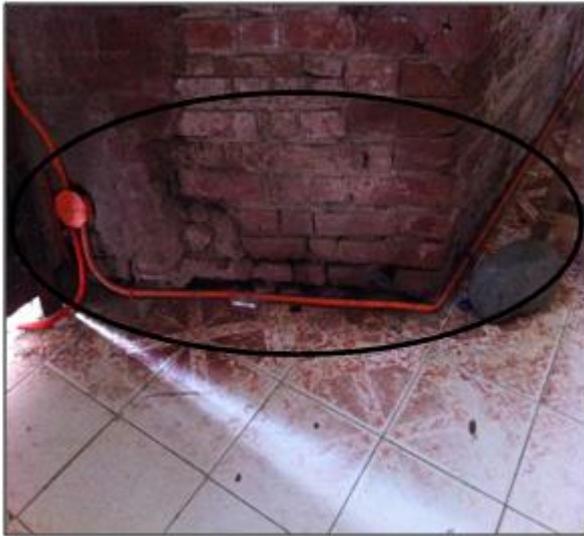
Figure 6: Human error (improper installation of electrical pipe) at St. Matthias Parish Church

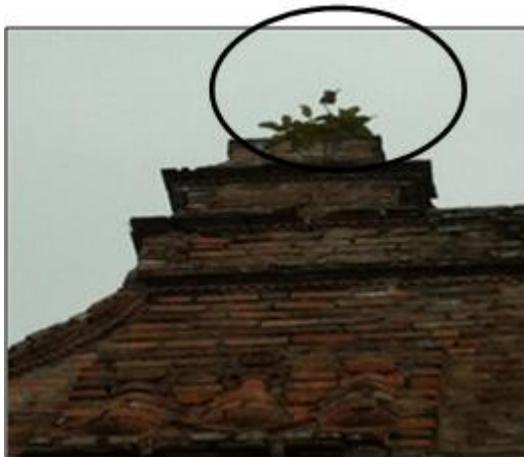
of Our Lady of Pillar Parish Church, St. Matthias Parish Church and San Pablo de Cabigan Church. However, minimal numbers of growing plants were observed at St. Rose of Lima Parish Church and at Our Lady of Atocha Parish Church.

Figure 7: Botanical growth at our Lady of Atocha Parish Church

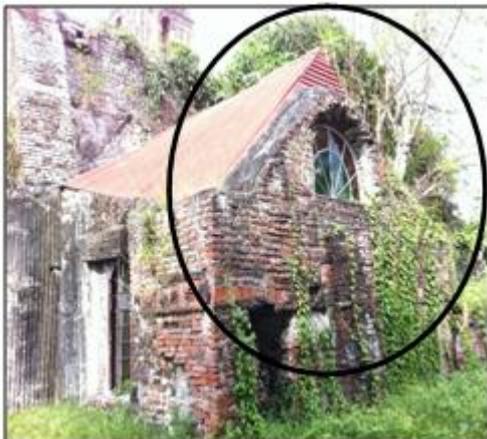
Figure 8: Abundant botanical growth at San Pablo de Cabigan Church
