Geomechanical Study of Inata Gold Mine Pits Rock Slopes, Burkina Faso (West Africa)

Pierre SAWADOGO¹, Ousmane BAMBA¹, Saga SAWADOGO¹, Tikou BELEM²

¹Université de Ouagadougou, 09 BP 848 Ouagadougou 09, Burkina Faso

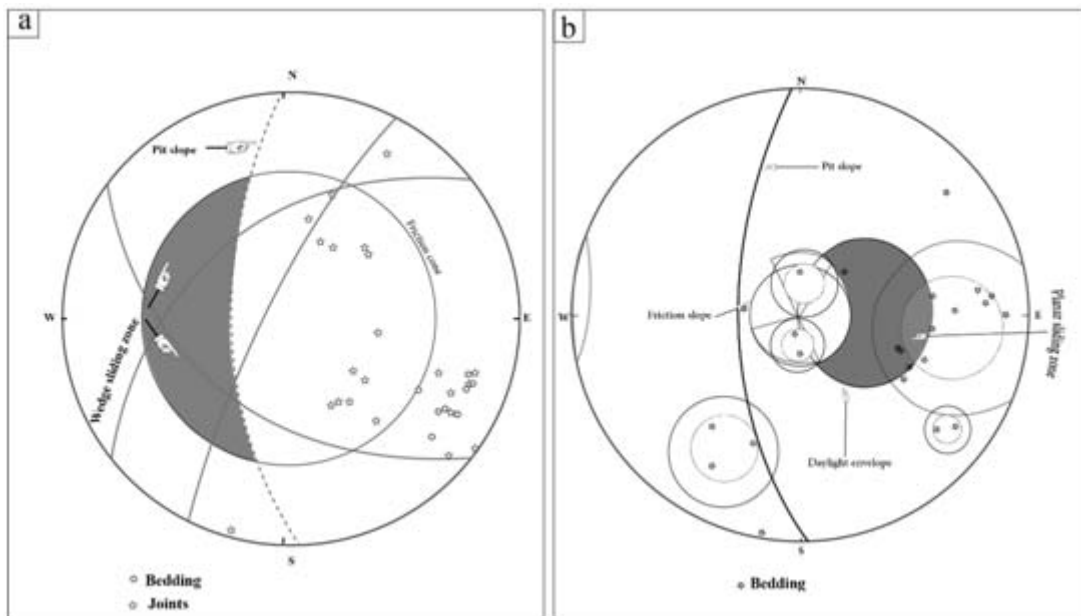
That is the corner failure mode is likely to occur in windows 4, 5 and 7 (Figure 5a and photo e) and planar failure mode may occur in window 7 (Figure 5b). The common feature of these windows is that they are all predominantly made of clay stone lithology. This strongly foliated formation is more susceptible to breakage than less distorted felsic intrusive rocks. The corner failure mode can be materialized in the stereogram Figure 5a with two families of intersecting planes in the rupture zone (gray area crescent moon). The areas concerned are those where the foliation is orthogonally intersected by joints thereby forming unstable blocks. As for a possible planar failure mode, it is shown in the stereogram in Figure 5b in which some discontinuities poles (marked by star) find themselves in the rupture zone. The planar failure is due to the foliation that seems to be the predominant geological structure in the area. In addition to this foliation, Inata is subparallel to parallel to the direction of the wall of the pit (280-310°) and steeply dipping angle of 70° on average. The tilting failure mode was not observed or considered in any of the windows studied. However, the

Figure 5: (a) stereogram indicating the possibility of a corner failure, (b) stereogram indicating the possibility of a planar failure.

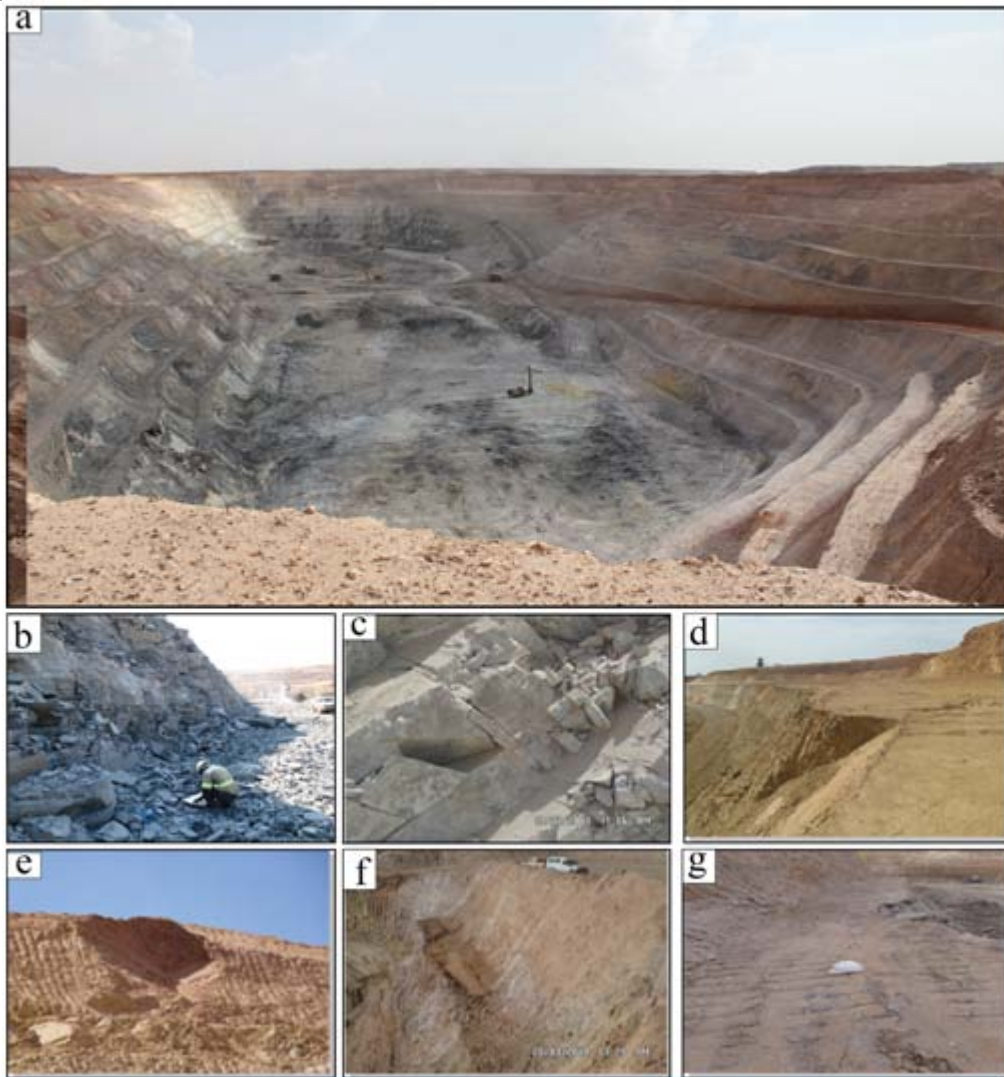
Furthermore, the qualitative assessment of the eastern wall of the North pit, shows fractures, joints and lithological contacts of various orientations (Photo c) as well as the effects of meteoritic runoff observable on the surface. The effects

induced by blasting and poor grading (Photo f and g) are also observed. Those findings are consistent with classification indices that reflect poor rock mass quality, and consequently rock mass is vulnerable to breaking.

Photo: (a) Shooting of the northern pit of Inata gold mine, (b) Geotechnical mapping session, (c) Joints of varied orientations, (d) Planar failure on the wall; (e) Corner failure on the intersection of two joints of different orientations; (f) Area of the wall where the sizing of the bleachers and slope are not respected: the step width < 5 m and slope angle is 70° instead of 65° ; (g) Fracture caused by blasting
