# Assessment of Heritage Churches in Isabela, Cagayan Valley

Susan C. Vallejo

College of Engineering, Architecture & Technology, Isabela State University, Ilagan, Philippines

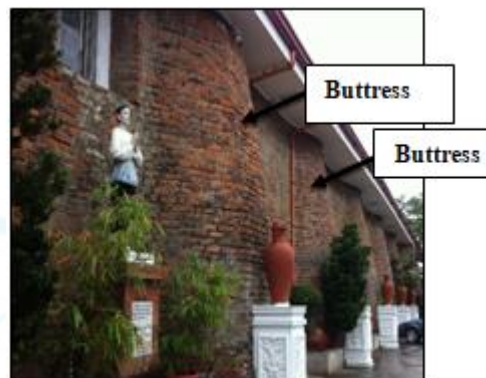
**Figure 1:** The presence of buttresses at our Lady of Atocha Parish Church

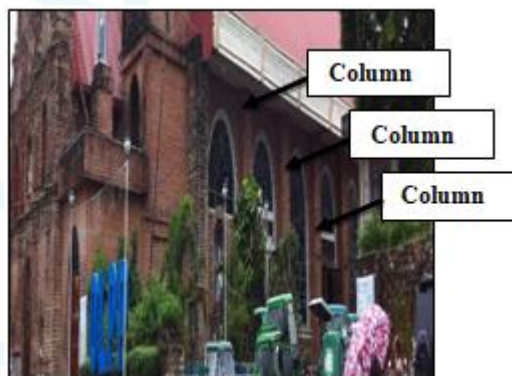
**Figure 2:** The presence of columns at our Lady of Pillar Parish Church

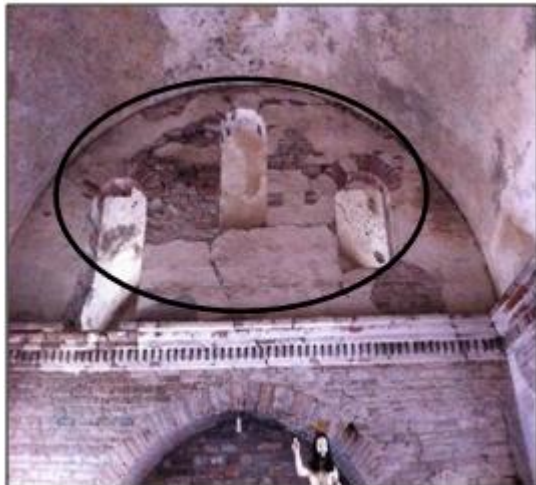
Table 3 shows the structural defects and damages of the churches. As observed, cracks were found on walls of all the five (5) churches as shown in fig. 3a and 3b below, while no cracks can be seen in floor slabs of these heritage buildings. From this result, the damaged on the walls of the churches which are caused by the presence of cracks contributes to the deterioration of the structural members of the building.

Figure 3 (a): cracks on the walls of the St. Matthias

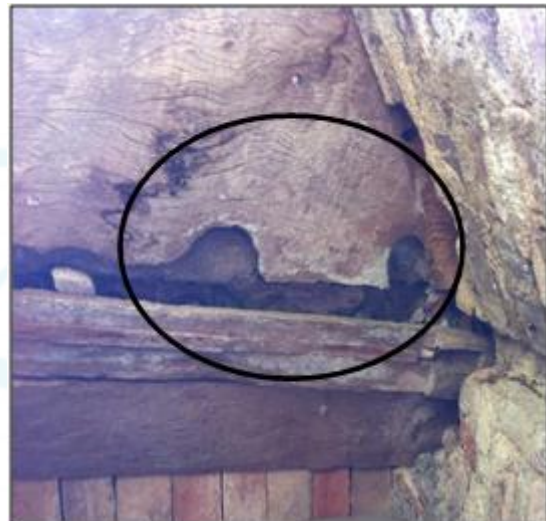
Moreover, there were human errors observed at St. Rose of Lima Parish Church, Our Lady of Atocha Parish Church and at San Pablo de Cabigan Church. An example is the improper installation of electrical wirings which was observed at St. Matthias Parish Church. However, it was observed that only at St. Rose of Lima Parish Church, where decay of timber structures was present.

Figure 4: Timber decay at Saint Rose of Lima Parish Church

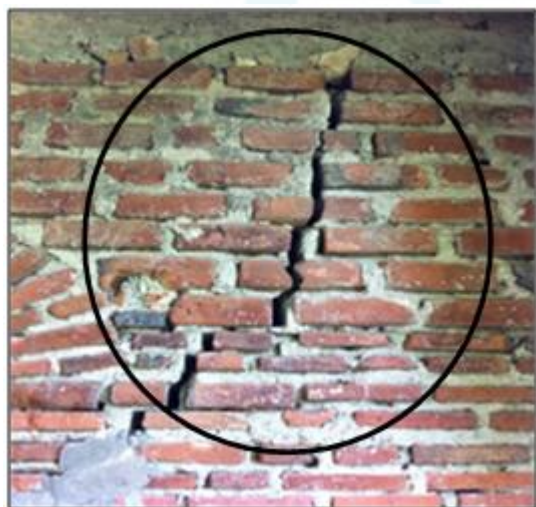
Figure 3 (b): Cracks on the walls of San Pablo de Cabigan Parish Church

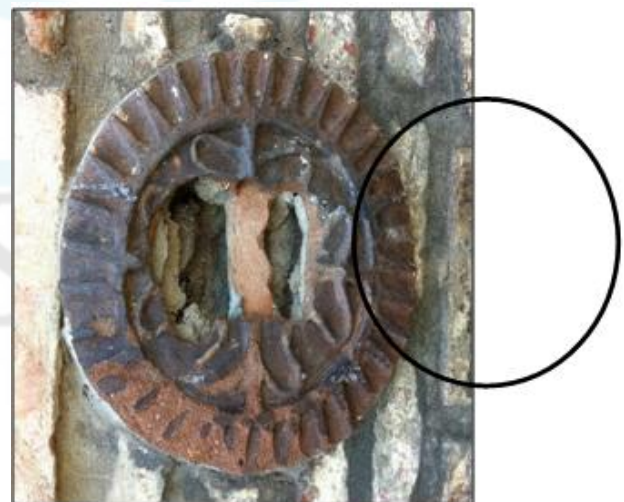
Figure 5: Damaged stoned details St. Rose of Lima Parish Church

Table 4 shows the non-structural defects and damages of the churches. As gleaned above, damaged stone details as well as botanical growth are present in all five (5) heritage churches. These botanicals grow abundant in sides and top

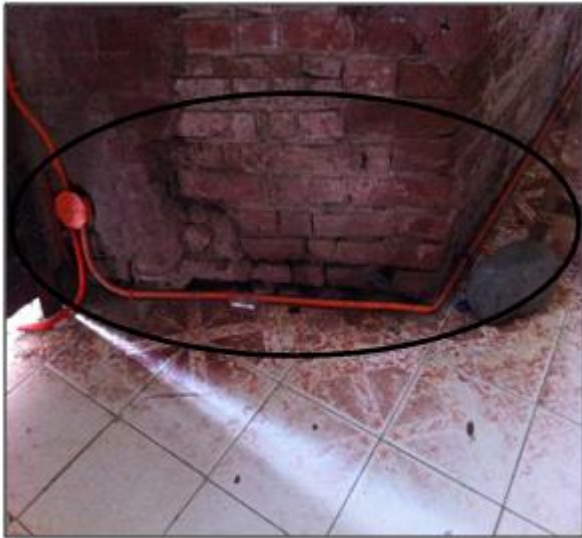
Figure 6: Human error (improper installation of electrical pipe) at St. Matthias Parish Church

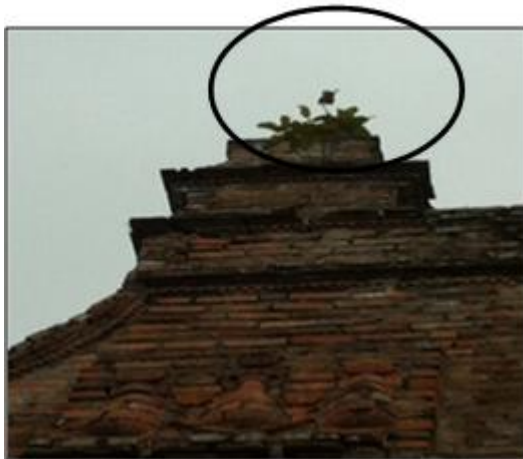
of Our Lady of Pillar Parish Church, St. Matthias Parish Church and San Pablo de Cabigan Church. However, minimal numbers of growing plants were observed at St. Rose of Lima Parish Church and at Our Lady of Atocha Parish Church.

Figure 7: Botanical growth at our Lady of Atocha Parish Church

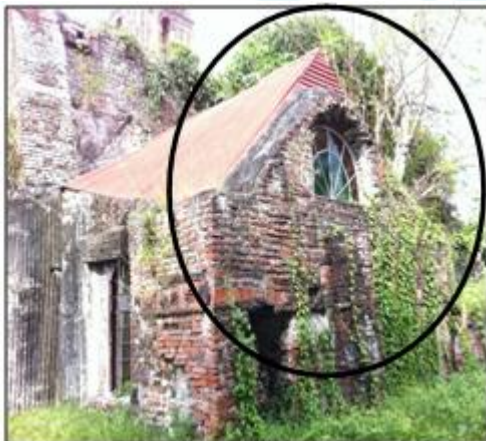
Figure 8: Abundant botanical growth at San Pablo de Cabigan Church
