The Accessibility of Disabled People in the Sports Arena of Semarang City

Abstract: *Sports arena as the public facility should be able to be relished by the entire communities, including the disabled people who have a hobby in sports. The laws which regulate the public facility for this community have been considered as ineffective due to many public facilities that still unable to fulfill the standard required. The ease of access provided for disabled people aims to facilitate them who have the interest towards sports for accessing the sports arena by utilizing the technology aimed at disabled people access. It might be possible if the ease of access provided for disabled people will make them as great athletes that will compete in the special sports of disabled people at international level. In this research, the method used is a descriptive method by observing the research object and comparing the standard for disabled people that has been regulated in Indonesian National Standard (SNI). The result expected from this research is the implementation of disabled-friendly access for disabled people on public facility designing especially sports arena.*

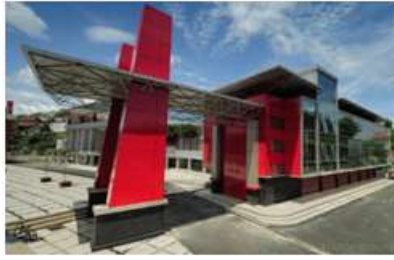
Figure 2: Tri Lomba Juang Sports Arena

The sports building of Tri Lomba Juang Mugas (Figure 2) is a public facility which established for sports activities of Semarang City people. This building which was inaugurated on 14 October 1972 has gone through renovation stages. Until present, the renovations have established a new face for Tri Lomba Juang sports building thus its able to attract a lot of visitors through its new fresh look

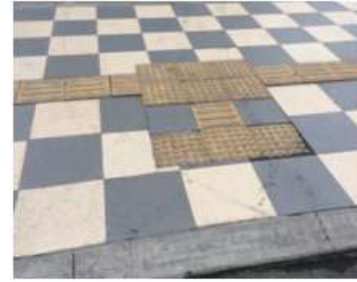
Figure 4: Guiding Line

The guiding line is not found on the front pedestrian of the Tri Lomba Juang sports building/arena, see. This is a certain indication which shows that this building has not been disabled-friendly for blind people. However, the guiding line can be found in the area across from Tri Lomba Juang sports building/arena (Figure 4) which is a pedestrian from the office area across from Tri Lomba Juang sports building/arena. There is a texture management that has no purpose but considered as a marker of the crossing area. However, if its function as a crossing marker, there is no zebra cross on the highway leading to Tri Lomba Juang sports building/arena. In the area towards the tennis court, the guiding block that supports the accessibility of the blind people is not found, as well as in the downstairs area as the access after the

entrance which the guiding block for the blind people is also not found.

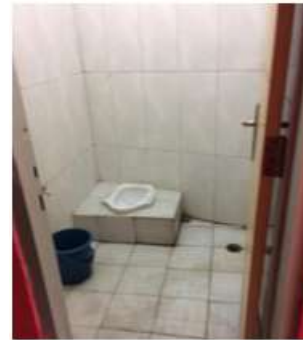
Figure 8: Tri Lomba Juang Toilet

In Tri Lomba Juang sports building/arena, there are several toilet rooms but the special toilet for disabled people is unavailable. It's relatively small and narrow with a size of 201 x 130 cm (Figure 8) that makes these toilets are difficult to be accessed by the disabled people, especially those who use wheelchairs because they have a minimal size for wheelchair rotation when performing bathing, washing, and latrine activities.
