The Accessibility of Disabled People in the Sports Arena of Semarang City

Abstract: *Sports arena as the public facility should be able to be relished by the entire communities, including the disabled people who have a hobby in sports. The laws which regulate the public facility for this community have been considered as ineffective due to many public facilities that still unable to fulfill the standard required. The ease of access provided for disabled people aims to facilitate them who have the interest towards sports for accessing the sports arena by utilizing the technology aimed at disabled people access. It might be possible if the ease of access provided for disabled people will make them as great athletes that will compete in the special sports of disabled people at international level. In this research, the method used is a descriptive method by observing the research object and comparing the standard for disabled people that has been regulated in Indonesian National Standard (SNI). The result expected from this research is the implementation of disabled-friendly access for disabled people on public facility designing especially sports arena.*

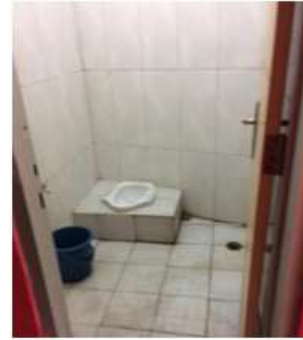
Figure 8: Tri Lomba Juang Toilet

In Tri Lomba Juang sports building/arena, there are several toilet rooms but the special toilet for disabled people is unavailable. It's relatively small and narrow with a size of 201 x 130 cm (Figure 8) that makes these toilets are difficult to be accessed by the disabled people, especially those who use wheelchairs because they have a minimal size for wheelchair rotation when performing bathing, washing, and latrine activities.
