Design and Experimental Investigation of Lapping Process for Productivity Improvement of I-Section Piston Rings

Abstract: Piston rings are the important components of a piston in an IC engine since it will seal the combustion chamber and regulate the oil consumption. In order to produce good quality of piston rings it is important to identify the defects in production process. In this project experimental survey has been carried out to identify the defects. From the survey by Pareto diagram flank chipping was identified as the major cause and from Ishikava diagram root cause has been identified that loading method in lapping process. The objective of this project work is to improve the productivity and decrease the scrap rate. FEA has been carried out in lapping process it is found that stresses was more than the yield strength of a material as a result flank chipping defect occurring in lapping process therefore design improvement is required. A new ring loading method has been developed in lapping process and FEA is carried out, it is found that stresses developed are closer to the yield strength and reduction of stress concentration. From experimental it is observed that there

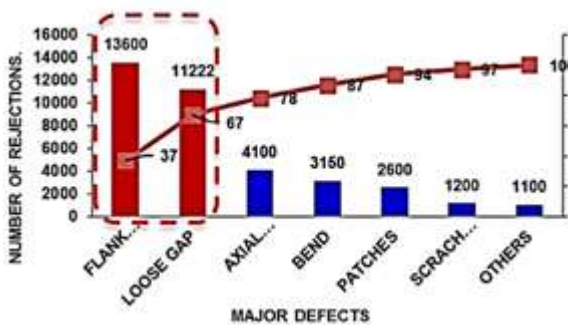
Pareto diagram chart is one of the quality improvement tool used to identify the major defect among many number of defects by 80:20 principle by controlling 80% of the cause can overcome the overall defect. In this project work based on the survey a Pareto diagram has been plotted from the observation it is found that flank chipping and loose gap are the major cause to the problem.

Figure 1: Pareto Diagram

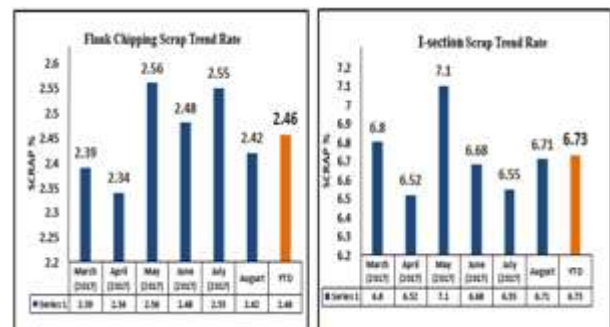
Figure 4: Scrap Trend Rate of I-Section Piston Rings

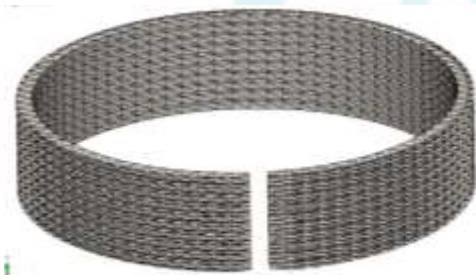
The meshed model with tetrahedron element is shown in **Fig.6.** The total number of elements are 18530 and nodes are 36356 in the component.

Figure 6: Meshed Model of I-Section Rings

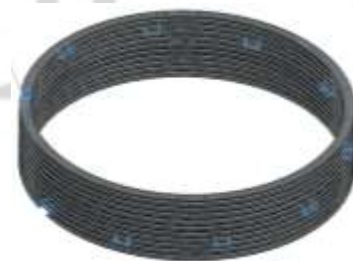
From the structural analysis it is observed that, the von-mises stress is more than the yield stress and critical region identified near the ring gap. According to distortion theory of failure, von mises stress is more than the yield stress as a results flank chipping defect occurring near the ring gap. Design improvement is done by changing ring loading method in lapping process. Instead of loading the piston rings at same ring gap, by placing the rings at equal angle one over the other. As shown in the Fig.10.

Figure 10: Design Improvement

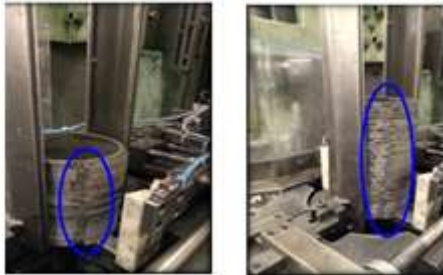
Figure 13: I-Section Rings Loading Method in Lapping Process before and After the Design Improvement

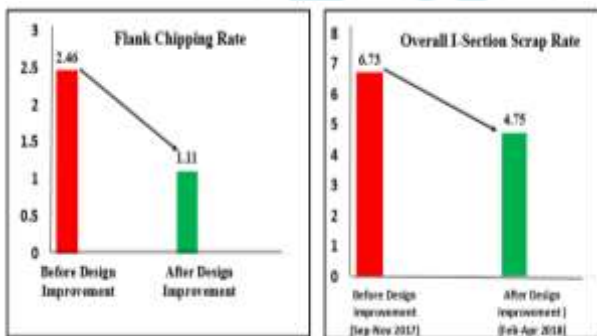
Figure 14: Scrap Trend Rate of I-Section Rings after Design Improvement

- 10) In experimental investigation Flank chipping rate reduced from 2.46% to 1.10% and thereby overall scrap rate of I-Section oil ring reduced by 6.73% to 4.75%.
