Infrared Thermography: A Tool for Defect Identification

Akash Padole¹, Dr. Sumedh Mhaske²

Abstract: *In this work, the potential of infrared thermography (IRT) to assess moisture related phenomenon was tested. Infrared thermography, due to its non-contact character that allows for quick surface mapping, represents a powerful tool for non-destructive testing (NDT) of materials and structures. As Infrared thermography is still not completely exploited and traditional methods are still employed. Due to the ambiguity in the analysis by using traditional methods of non-destructive testing this method emerges as an easy and quick method. So, in this paper, different areas were taken for inspection on the college campus and at the same location traditional method of NDT were also performed and the results are compared. The same has also been performed by casting the concrete cube having porous pipes inserted into a cube and the source of leakages was detected. At last the cost required by the conventional method and IRT was compared and found that the cost required by IRT was much economical than convention method Thus, anomalies were found during a short-elapsd time. The infrared therm

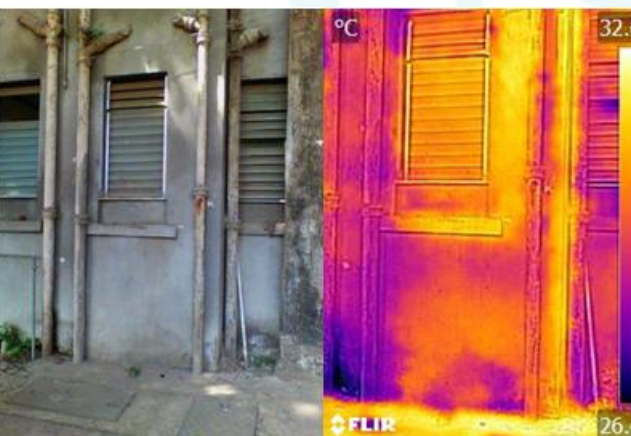
Figure 6: Behind Computer Department Toilet

Figure 6 is the newly constructed lavatory in the department. In this, the portion in the pink shows some of the leakages of which mostly accumulated near the pipelines.

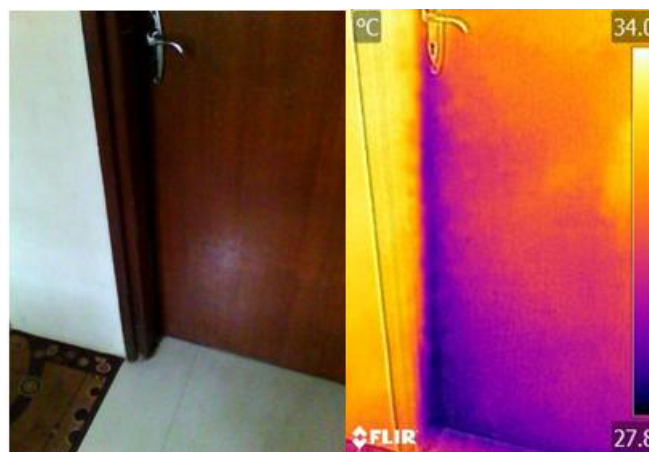
Figure 8: Air leakage through Meeting room

In Figure 8 the air leakage of the door has shown even though the door is closed the cold air is leaking between the door and the casing.

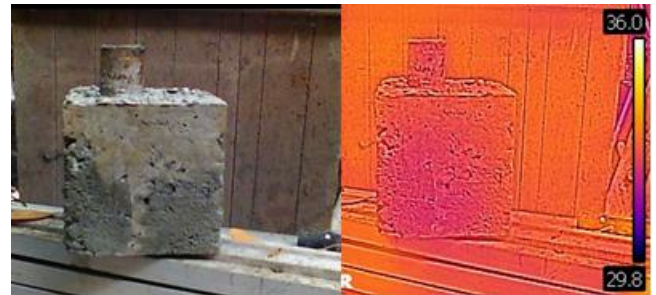
Figure 12: Before pouring water

Figure 12 is the thermogram prior to pouring the water. After that, the water started leaking out of the concrete block. In Figure 13 as we can see in the normal photo it was hard to predict the exact location of leakage but in thermogram, the dark violet shows the most accumulation of water which is ultimately the source of leakage.

The test involved the evaluation of the surface temperature variation using a thermal infrared camera and source of heat as the sun to simulate the source of leakages on the concrete cube. The sample was cast in 15x15x15 cm³ by inserting two cast iron pipes diagonal to each other. Casted cube is designed in accordance with IS code as shown below.

The test was performed under approximately constant environmental conditions (ambient temperature = 30°C). The concrete cube has placed in the open environment for nearly two hours so that the cube got heated uniformly. The thermograms are taken at nearly 30cm from the cube so that the source of leakages can be detected precisely in the cube sample.
