Non-destructive Evaluation of an Existing Concrete Structure using Load Test

Abstract: Forensic Engineering involves both curative or remedial and post-failure investigations. The former provides, the needed technical facts on what to do with the structure; while, the latter provides technical data to prevent the recurrence of the same for the policy and decision makers. The research work focused on non-destructive evaluation of a five-story concrete building which was partially burned. Portion of the third and fourth floors slabs and supporting structural members were subjected to intense heat. It was necessary to assess the existing conditions of the building to determine whether or not it is still fit for occupancy. For this purpose, load tests were performed on the identified third floor areas. The test results indicated that the affected areas had adequate but reduced strength for future use or maybe retrofitted to restore the original design load carrying capacity of the structural members affected and the structure as a whole. It is further recommended that other tests be conducted to ensure that management has enough technical data to decide on what to do with the building

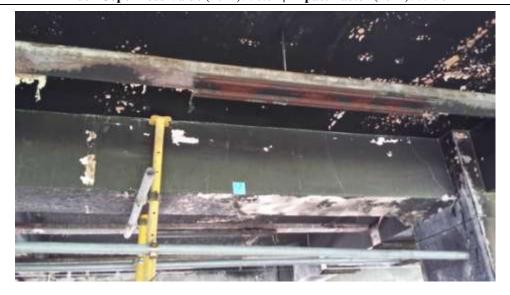
Setting of horizontal and vertical controls for deflection measurements (Pictures 1 to 6). Picture 1.

Six(6) slab panels were tested, all in the third floor. The number and arrangement of spans or panels to be tested were selected to maximize the deflection (midspan) and stresses in the critical regions of the structural elements. Presence of hairline cracks in slab panels and beams were also considered as factor while selecting the test panels. American Concrete Institute (ACI 318), provides that the test load, (including dead and already in place load) should not be less than 0.85(1.4DL + 1.7LL). As recommended by the of American Society of Civil Engineers¹⁸, live load of 60 psf (2.87Kpa) for shops and apartments, and 100 psf (4.75Kpa) for assembly areas and corridors was used to calculate the test load. In case, a panel is partially used as an assembly area and partly for the ordinary use, an average live load should be used. The test load was applied in four equal increments in accordance with the recommendation by the ACI. Sand bags of 20 kgs (44 lb) were used for loading the floor slabs, (see picture 6). Figures 1 & 4show the arrangement and actual placement of deflection lines (also see pictures 1 to 5), and loading arrangement (figure 2.) by using 20 kgs bags loose sand.

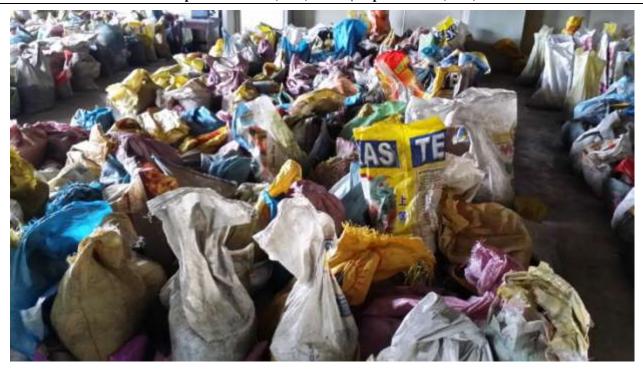
Picture 6. LOADS applied to the SLABS AND BEAMS
