Design and Experimental Investigation of Lapping Process for Productivity Improvement of I-Section Piston Rings

Abstract: Piston rings are the important components of a piston in an IC engine since it will seal the combustion chamber and regulate the oil consumption. In order to produce good quality of piston rings it is important to identify the defects in production process. In this project experimental survey has been carried out to identify the defects. From the survey by Pareto diagram flank chipping was identified as the major cause and from Ishikava diagram root cause has been identified that loading method in lapping process. The objective of this project work is to improve the productivity and decrease the scrap rate. FEA has been carried out in lapping process it is found that stresses was more than the yield strength of a material as a result flank chipping defect occurring in lapping process therefore design improvement is required. A new ring loading method has been developed in lapping process and FEA is carried out, it is found that stresses developed are closer to the yield strength and reduction of stress concentration. From experimental it is observed that there

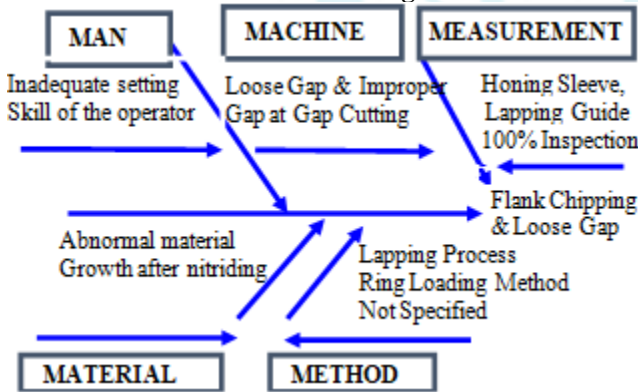
Figure 2: Cause and Effect Diagram

By Ishikawa diagram the possible cause and its effects are identified that are shown below in Fig.2

The main potential cause for the flank chipping defect is ring loading method in lapping process. In this process rings loading method not specified in the control plan and all rings are loaded in a same direction that is ring gap is in the same direction placed one over the other, therefore there will be unequal pressure distribution on the ring and stress is concentrating at a single point and this leads to cause of flank chipping.
