Identifying the Factors Causing Degradation of Urban Waterbodies: Case of Sakkardara Lake

Author: Ar. Maitreyi Shrikant Parkhi (Architect)

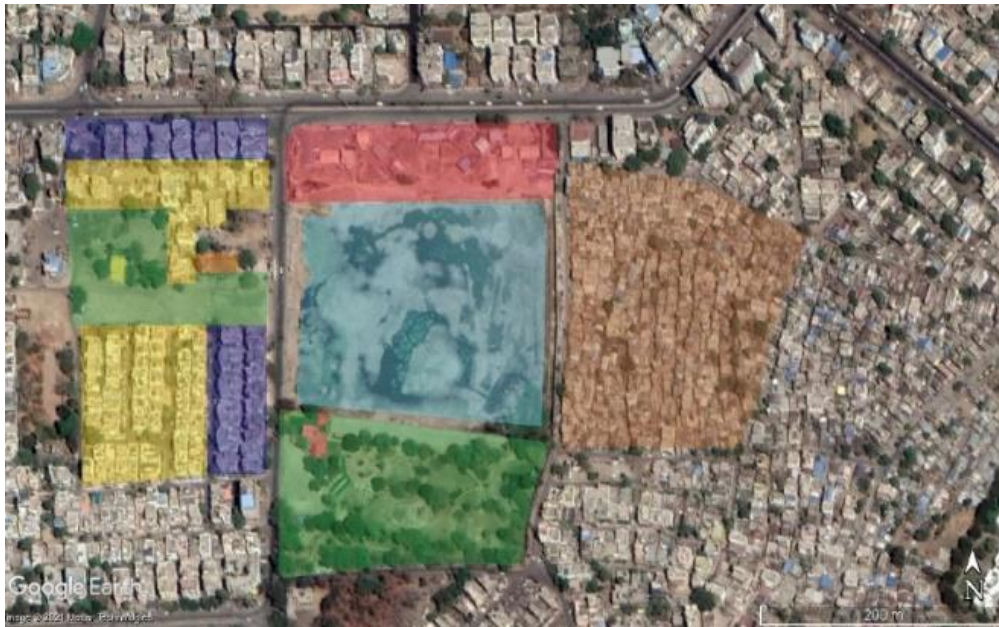
Lake
Residential
Slums

Open space
Commercial
Mix-use

Almost all of the area around the lake is demarcated as residential and commercial zone in the Development Plan of Nagpur with the only exception being the Southern edge which has been reserved as a green area. Lake view is blocked due to the barricades around the lake. Bollywood Centre point (Entertainment plaza) is located on the Northern bank of the lake. Construction Debris (Demolition of compound wall) of Bollywood Centre point is dumped in

the lake. Slum and Residential area is on the Eastern side of the lake. The habitants of slum settlements located are seen using the readily available lake water for domestic activities. Garbage is dumped by the slum dwellers into the lake. Southern edge of the lake was developed as a recreational open space (garden and Restaurants) which is now closed and inaccessible. Western side of the lake has residential and commercial development. Lakshmi Narayan Temple is also located on the western side of the lake. (fig. 1 here)

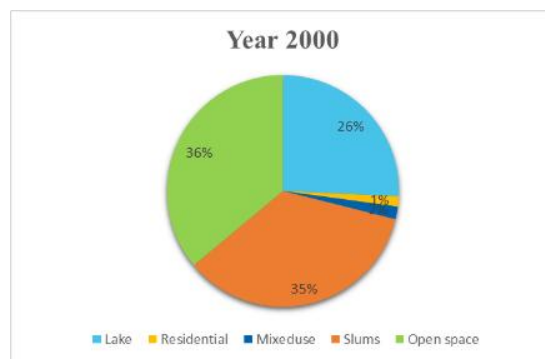
Figure 4

Year 2000	Area in acre
Lake	9.05
Residential	0.50
Mixeduse	0.62
Slums	12.30
Open space	12.68

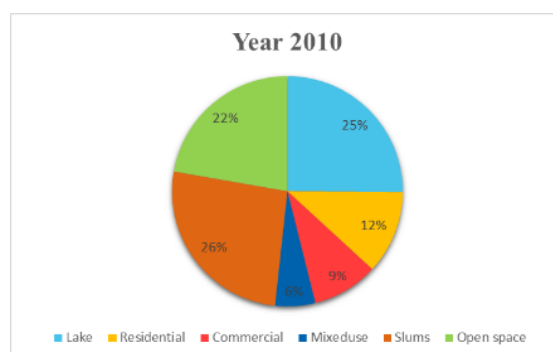
Year 2010	Area in acre
Lake	8.70
Residential	4.07
Commercial	3.21
Mixeduse	1.95
Slums	9.02
Open space	7.71

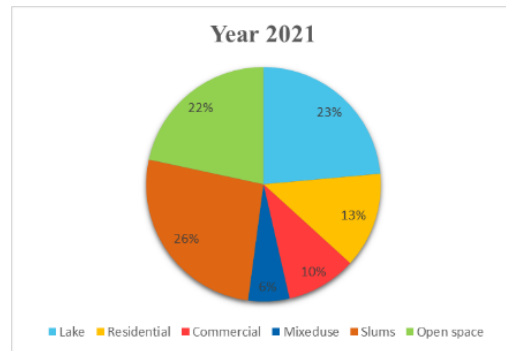
Year 2021	Area in acre
Lake	8.09
Residential	4.53
Commercial	3.32
Mixeduse	1.95
Slums	9.02
Open space	7.42
