# Infrared Thermography: A Tool for Defect Identification

Akash Padole<sup>1</sup>, Dr. Sumedh Mhaske<sup>2</sup>

**Abstract:** *In this work, the potential of infrared thermography (IRT) to assess moisture related phenomenon was tested. Infrared thermography, due to its non-contact character that allows for quick surface mapping, represents a powerful tool for non-destructive testing (NDT) of materials and structures. As Infrared thermography is still not completely exploited and traditional methods are still employed. Due to the ambiguity in the analysis by using traditional methods of non-destructive testing this method emerges as an easy and quick method. So, in this paper, different areas were taken for inspection on the college campus and at the same location traditional method of NDT were also performed and the results are compared. The same has also been performed by casting the concrete cube having porous pipes inserted into a cube and the source of leakages was detected. At last the cost required by the conventional method and IRT was compared and found that the cost required by IRT was much economical than convention method Thus, anomalies were found during a short-ela

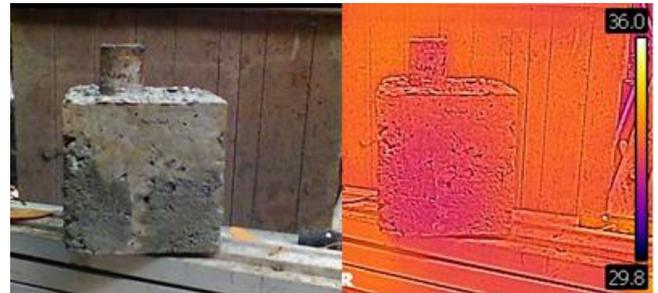
Figure 12: Before pouring water

Figure 12 is the thermogram prior to pouring the water. After that, the water started leaking out of the concrete block. In Figure 13 as we can see in the normal photo it was hard to predict the exact location of leakage but in thermogram, the dark violet shows the most accumulation of water which is ultimately the source of leakage.
