Geomechanical Study of Inata Gold Mine Pits Rock Slopes, Burkina Faso (West Africa)

Pierre SAWADOGO¹, Ousmane BAMBA¹, Saga SAWADOGO¹, Tikou BELEM²

¹Université de Ouagadougou, 09 BP 848 Ouagadougou 09, Burkina Faso

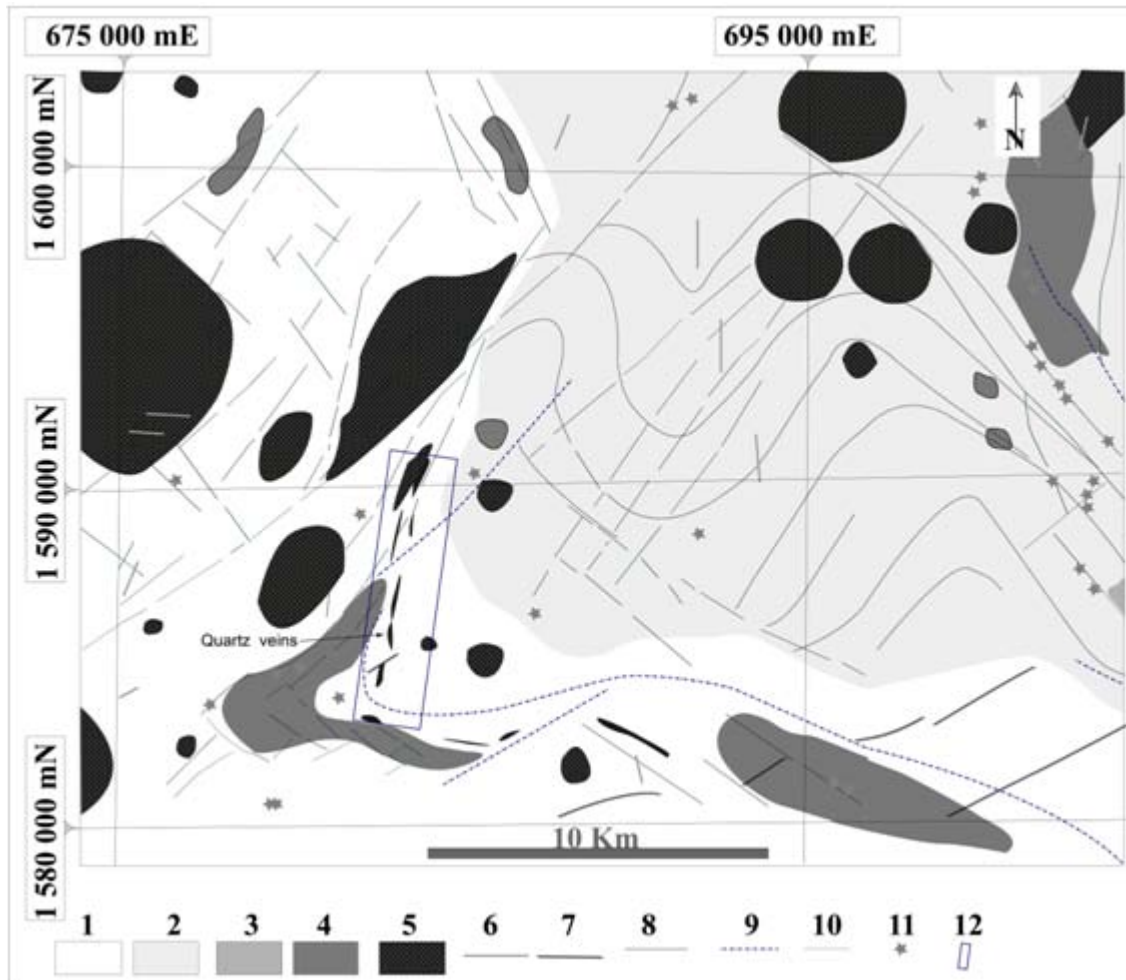
compression in ductile brittle regime (Figure 3). These lithological and structural configurations make footwalls susceptible to breaking.

Figure 3: Synthetic lithologic and structural map of Inata gold mine context. (1) mixed epiclastic volcanoclastic (2) turbiditic sediments (3) intermediate to mafic volcanites (4) gabbro-diorite (5) granite (6) quartz veinlets (7) doleritic dykes (8) bedding (9) thrust contact (10) inferred fault/shear zone (11) artisanal work (12) study area

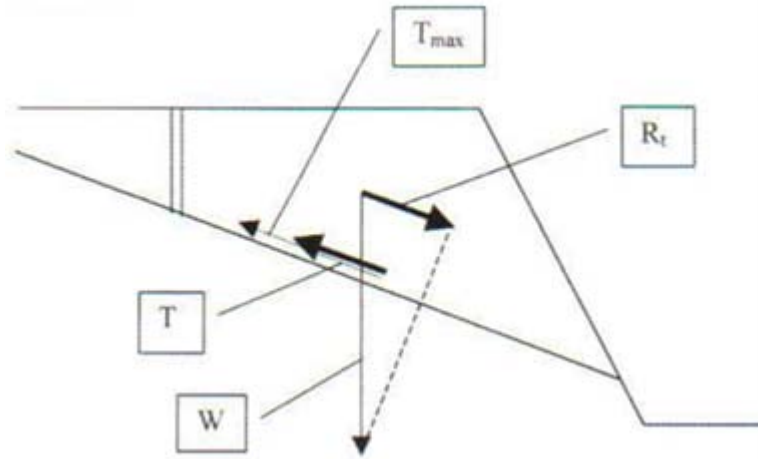
considered (Figure 4). The safety factor F is then the ratio of the maximum resisting force that can oppose the slipping to the driving force tending to cause slipping. There is therefore slope failure if F is less than 1.

Figure 4 : Evolution of stability for a plane slip (Hantz, 2001): W : weight; R_t : Driving force; T : Resistant force; T_{max} : maximum resistance force $F = T_{max}/R_t$ is the safety factor.
