Distribution of Water Harvesting Structures in Chevella Basin, Telangana State, India

Abstract: A watershed provides a natural geo-hydrological unit for planning any developmental initiative. The approach would be treatment from "ridge to valley". The present study has made on the observation of Chevella basin to identify the suitable locations and to suggest appropriate RHS. The basin occupied with black soil mixed with calcareous and gravel. Geomorphic units identified are moderately dissected plateau, shallow weathered plateau, shallow valley fill, slightly dissected plateau, pediment and inselberg. 419 locations are marked for the construction of various RHS. Out of this it is suggested to construct 41 percolation tanks, 189 check dams, 35 check walls and four farm ponds, one earthen bund and 149 rock fill dams. It is felt that community participation is essential for the successful implementation of watershed development program.

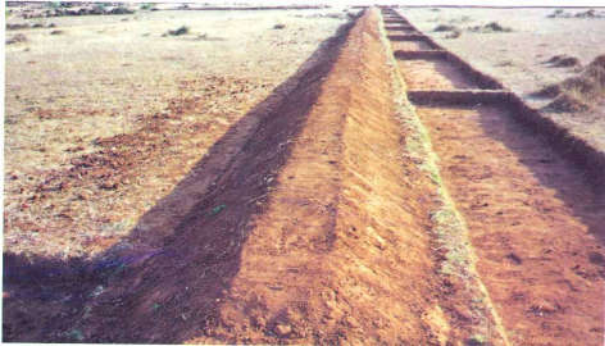
Figure 3.1: Earthen bund

It is one of the popular soil conservation structures and is practiced at large scale in all Chevella watershed villages. The bunds (Figure 3.1) are constructed on agricultural land with the aim of arresting soil erosion and improving the soil moisture. They would lie along the boundary of the field. The soil erosion from the field is reduced and the waste weir in the field helps for safe disposal of the excess water from the field.

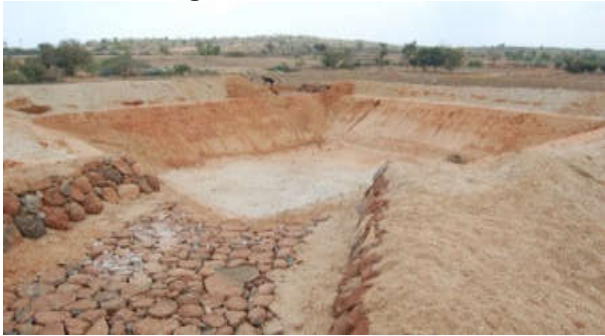
Figure 3.2: Farm pond

The main objective of farm pond (Figure 3.2) is to store the water from the surface runoff in the ponds and use for the irrigation purpose. The water stored in the farm ponds is generally used when the rains are irregular.

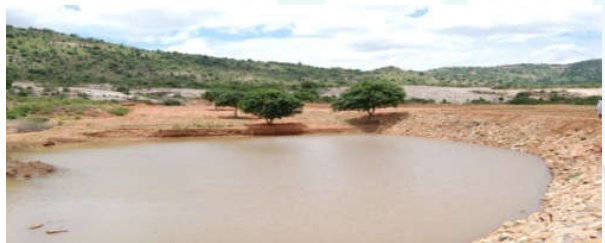
Figure 3.3: Percolation Tank

The percolation tanks are artificially created surface water bodies, submerging a land area with adequate permeability to facilitate sufficient percolation of impounded surface runoff (Figure 3.3). These structures are recognized as a dependable mode for groundwater recharge in the hard rock terrain. The hard rock areas with limited to moderate

water holding and water yielding capabilities often experience water scarce situations due to inadequate recharge, indiscriminate withdrawal of groundwater and mismanagement. A tank can be located either across small streams by creating low elevation check dams or in uncultivated land adjoining streams, through excavation and providing a delivery canal connecting the tanks and the stream.

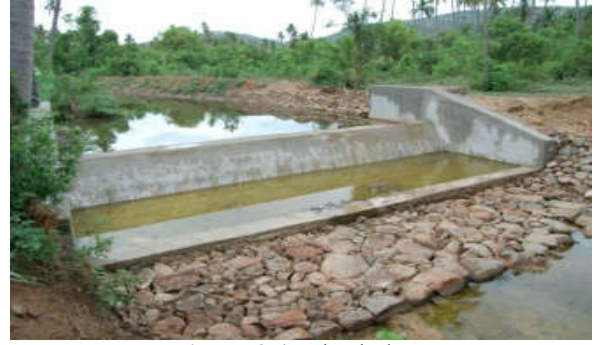
Figure 3.4: Check dam

These are small scale, low cost structures (Figure 3.4), generally built across a small stream to store the rain water from flowing away. They check the velocity of water, reduce the erosive force of water, store water in stream courses, increase groundwater recharge and increase soil moisture conditions (Murty, 1998). This harvested water provides direct irrigation for the surrounding areas, through direct lift and ground water percolation (Shingi and Asopa, 2002).

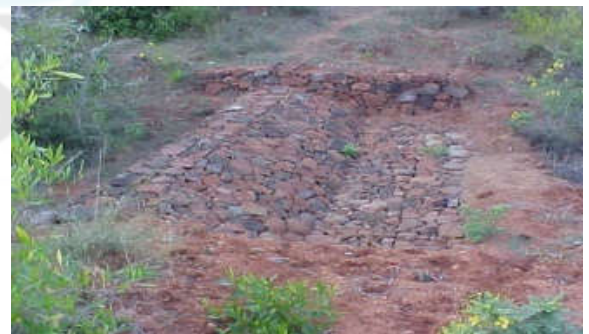
Figure 3.5 (a) Rock fill-dam

A rock-fill dam is a small, temporary or permanent dam constructed across a drainage ditch, swale, or channel to lower the speed of concentrated flows for a certain design range of storm events (Figure 3.5a). A check dam can be built with wood logs, stone, pea gravel-filled sandbags or bricks and cement (RUFFINO 2009). Reduced runoff reduces erosion and gully erosion in the channel and allows sediments and other pollutants to settle out.

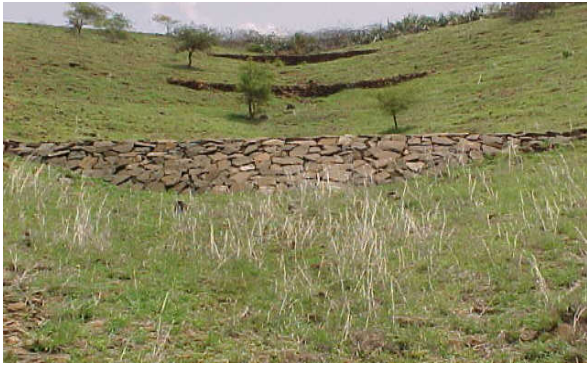
Figure 3.5 (b): Loose Boulder Structure

This is also a type of Rock fill dam aimed to reduce the soil erosion of soil on the upper side of the catchment area. By constructing the bunds with rocks across the gully the velocity of runoff and soil erosion can be reduced and water percolates in to the soil (Figure 3.5b). Gradually the gully will be filled with the silt and the area can be brought for cultivation in the field. It can be constructed at low-cost and with locally available materials.

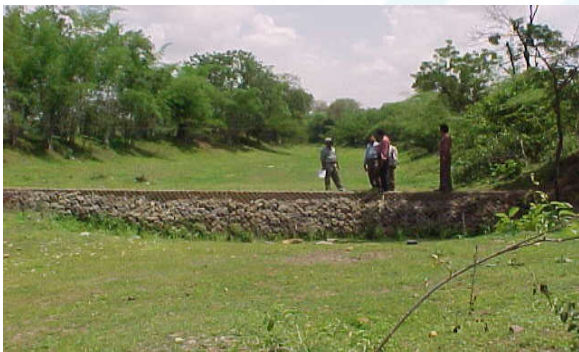
Figure 3.5 (c): Water harvesting gabion

It is similar to loose boulder checks, but are constructed across bigger streams and have their own catchment area. These structures can be constructed on flatter regions. The flatter the upstream slope, the more will be the storage.

Along with slowing down the runoff these structures also help to store the water temporarily, if the bed is impermeable. The structure is generally reinforced with wire mesh for stable embankments which oppose strong currents (Figure 3.5c). The bunds made by covering the loose stones by mesh are called “Gabion Bandhara” The areas where the slope of the nala is greater than 3% and the rainfall is heavy in such conditions the loose boulder structures cannot sustain, so in such cases the Gabion Bandhara are preferred.
