A Study for Remedial Measures of Improper Temperature Indication System Used in IC Engines to Minimize Engine Losses

Abstract: *The study is based on the proper maintenance and working of I.C engine used in passenger cars. During the study of car cooling system, it is found that due to improper temperature indication system adopted in passenger car in India, there will be overheating in the engine, which leads to engine losses. Another major problem is that, overheating of engine is not detected quickly enough by the cooling system. The temperature meter shows the normal temperature of engine for fairly long duration, although the engine is overheated. Thus driver keeps on running the vehicle in overheated condition and could not judge the overheating merely by looking at temperature meter. The indication he gets regarding overheating are confusing and judgmental only. He has to judge the problem in cooling system on his own. And will run the engine for a quite period of time in heated condition which leads to engine loss. In today's scenario, the design of any system is done keeping user friendliness in mind such that the working must be convenient and at the same time it must be

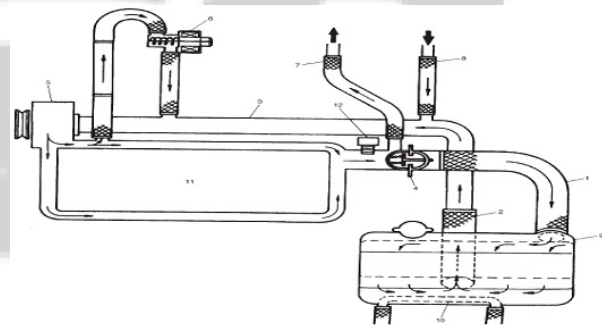
Figure 1: Engine cooling system

1. Radiator inlet hose 5 Water pump 9 Radiator
2. Radiator outlet hose 6 IAC Valve 10 Oil cooler (A/T only)
3. Water intake pipe 7 Heater inlet hose 11 Engine
4. Thermostat 8 Heater outlet hose 12 ECT sensor

The working of system is clear from the flow direction of coolant as shown. Hot coolant enters the radiator from the top and flows down ward and gets cooled, as the fan takes away heat from coolant by transferring its heat to air flowing across the radiator. This low temp coolant is than pumped to engine where, coolant absorbs engine heat and cools the engine. The hot coolant coming out from engine block then flows through thermostat valve (the function of this valve is to avoid flow of coolant through radiator until the engine temperature reaches normal working temperature). As clear in the figure 1 temperature sensor is fitted near the thermostat valve and the function of this sensor is to sense the temperature of coolant, which in turns indicates the temperature of engine. The signal from the sensor is transmitted to ECM and to the temperature meter on dashboard. It is on this meter, where the driver gets indication of condition of engine weather it is running at normal temperature or at an overheating temperature [3].

Before actually coming to the problem let us first discuss about engine cooling system used in modern cars. The cooling system consists of radiator cap, radiator, coolant reservoir, hoses, water pump, cooling fan and thermostat [2]. The complete system is shown in Figure 1.

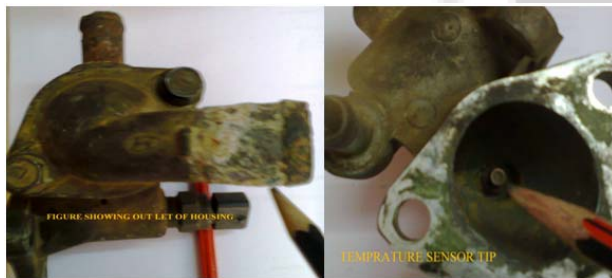
Figure 2: Showing Car's Thermostat Housing

This housing is fitted to the right side of the engine assembly. The picture indicates the out let of the housing which is connected to the radiator with the help of hose pipe. At the bottom part of housing ECT sensor is fitted. The probe i.e., tip of the sensor is clearly visible when the housing is dismantled as shown in figure 2. The next two pictures as shown in figure 3 show side wise and bottom wise gap between the temperature sensor tip and the body.

With the understanding of working of cooling system and the method of indication of temperature, we can point out the fact where the problem gets arise. The problem is tried to understand with the help of thermostat housing of car as shown in figure 2.

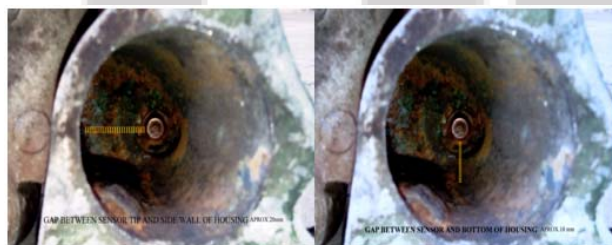
Figure 3: Showing Orientation of Temperature Sensor

When the level of coolant get reduced to very low level, the ECT sensor i.e. engine coolant temperature sensor does not come in contact with the sufficient quantity of coolant as the amount of coolant in the system is very low and the

proper contact between the temperature sensor probe and hot coolant will not take place, which leads to improper or no sensing of coolant temperature and thus does not able to provide correct information through temperature meter. So engine keeps on running in overheated condition while the temperature meter shows normal running temperature.

Now to find solution to the problem each point is taken one by one. As per first point which indicates some design problem. Temperature sensing system i.e., ECT sensor location is shown through picture, which gives clear indication that the orientation of the sensor is not proper as during running engine at a very low level coolant, the proper contact between sensor and hot coolant does not takes place. The sensor is in contact with the air in system instead of coolant, due which the temperature of air is sensed by sensor and leads to false indication on temperature meter.

In rectification for this design problem, one of the solutions could be change in the orientation of ECT sensor. ECT sensor must be fitted at such a position that the sensor tip should always be in contact with the hot coolant no matter what the level of coolant is. For this the design of thermostat housing must be changed completely, which will require design and manufacturing of complicated casting in which ECT sensor is mounted. Another method to rectify the problem is to keep the level of coolant proper always in all driving condition as mentioned in the second point of cause, which mentions that it is due to negligence at the end of user or inability of user to understand the importance of proper maintenance
